# CHARACTERISATION OF OUTGASSING CONTACT MATERIALS FOR MINIATURE RELAYS

L. Koller, M. Bizjak\* and S. Spruk

Institute for Electronics and Vacuum Technology Ljubljana, Slovenia

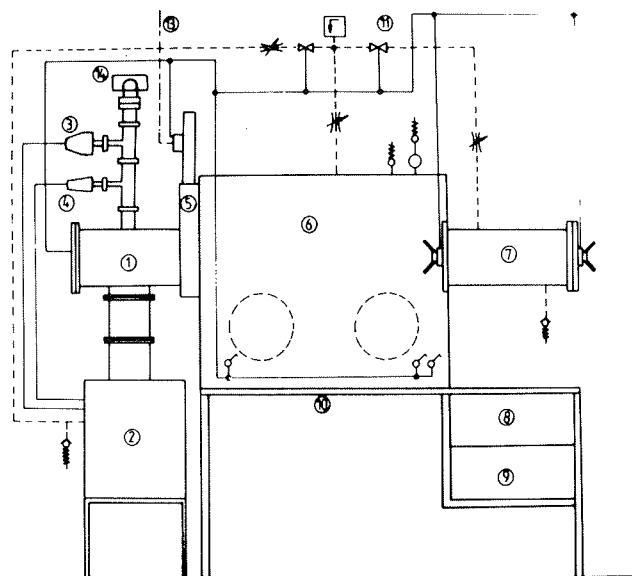
Fig. 1a: Experimental vacuum system (scheme) for outgassing process for hermetic relays: 1-vacuum chamber, 2-vacuum system, 3-PNG head, 5-mass spectrometer, 6-plate valve, 7-N<sub>2</sub> chamber for final hermetic relays encapsulation

The experimental set up, designed and assembled specifically for vacuum outgassing of hermetic relays is shown in Fig. 1. The vacuum system consists of rotary

vane pump and turbomolecular pump enabling to attain a vacuum of at least  $1 \times 10^{-6}$  mbar. The vacuum chamber which can be baked up to  $300^\circ\text{C}$  is equipped with a resistive heater. A thermocouple Fe-CuNi, 0.5 mm in diameter, is in thermal contact with one of the outgassed relays in the middle of the vacuum chamber. For residual gas analysis the quadrupole mass spectrometer Leisk 1000 M with AMU 2-100 has been used. Prior to the final hermetic encapsulation the relays are baked at constant temperature of  $125^\circ\text{C}$  in a vacuum of  $1 \times 10^{-5}$  mbar for several hours. The residual atmosphere has been analysed every hour.

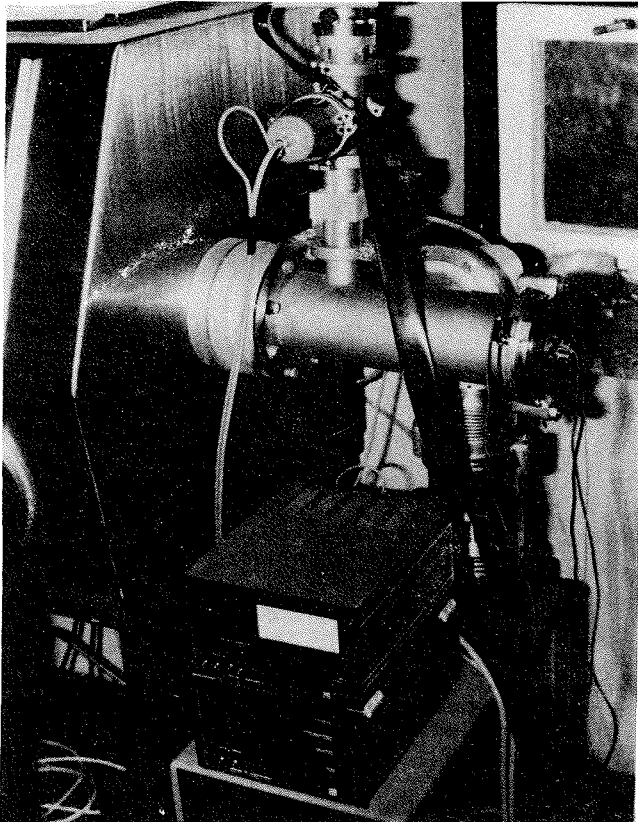
Fig. 1b: Experimental vacuum system (photograph)

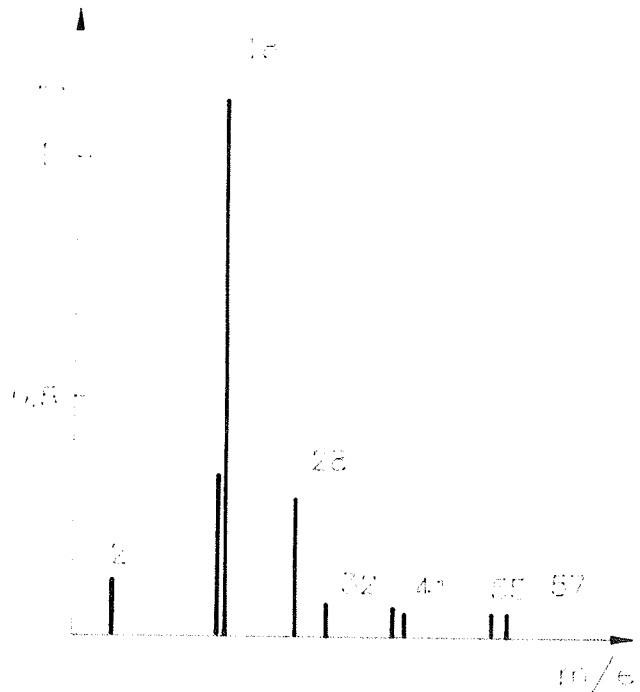
Fig. 2: Mass spectrum showing the outgassing products of the empty chamber

The first analysis of residual atmosphere was made in an empty and unbaked stainless steel chamber after a few days of continuous pumping. The base pressure in chamber was  $2 \times 10^{-6}$  mbar. Mass spectrum in Fig. 2 shows the outgassing products in the empty chamber. This spectrum is typical for a standard vacuum system with very small air leaks and no unusual gas sources; it shows that the most prominent outgassing product in the empty vacuum chamber is a mixture of water vapour, CO and  $\text{N}_2$ ; small quantities of hydrogen and some hydrocarbons are also released in the empty chamber at this temperature as expected.

The spectrum in Fig. 4 was obtained after 24 hours baking of the empty chamber at the same temperature. Total pressure attained was  $1.3 \times 10^{-6}$  mbar. This spectrum is similar to that shown in Fig. 2, which shows the empty chamber without baking.

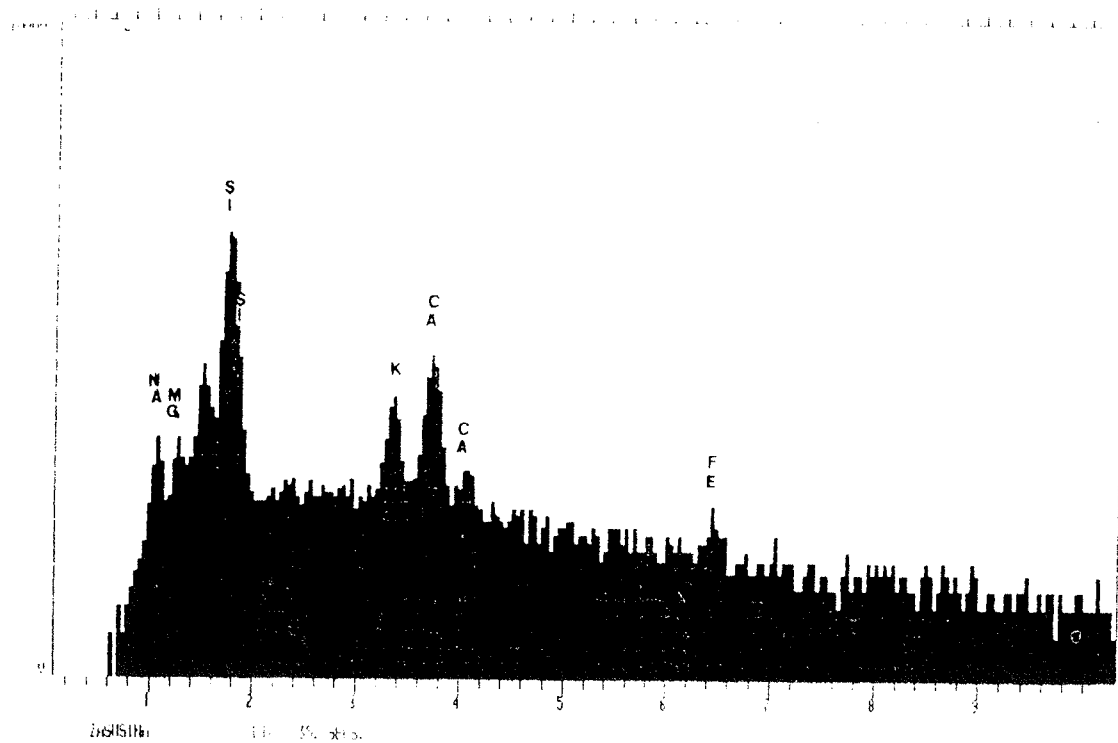
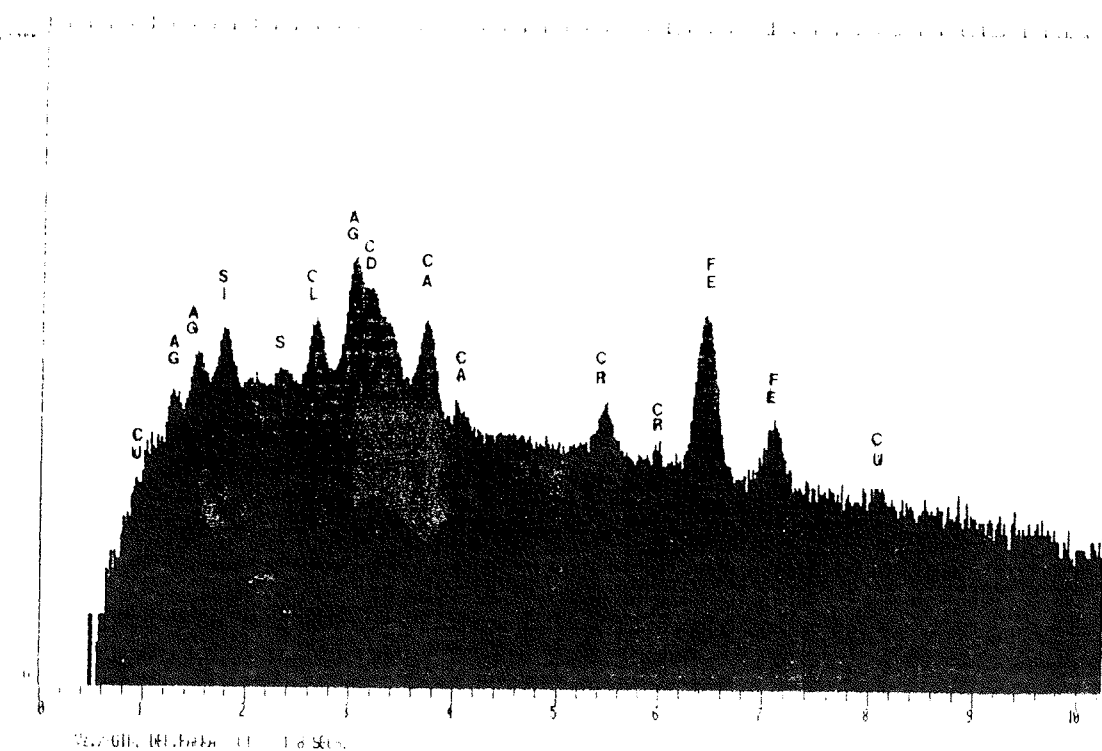
Fig. 7a: Mass spectra of the outgassing products of contaminated miniature relay (contacts AgCdO/AGPHOR) at 125°C in a vacuum of  $1 \times 10^{-5}$  mbar after 24 hours

When contact resistance of miniature relays with AgCdO contacts was measured after outgassing considerable

increase was noticed. Therefore some relays were opened and their contacts analysed (Fig. 7a and 7b). Dark spots found on the contacts probably caused the increase of contact resistance. It seems that the relays mentioned were not sufficiently outgassed. Detailed examination of the phenomenon is planned in the near future.

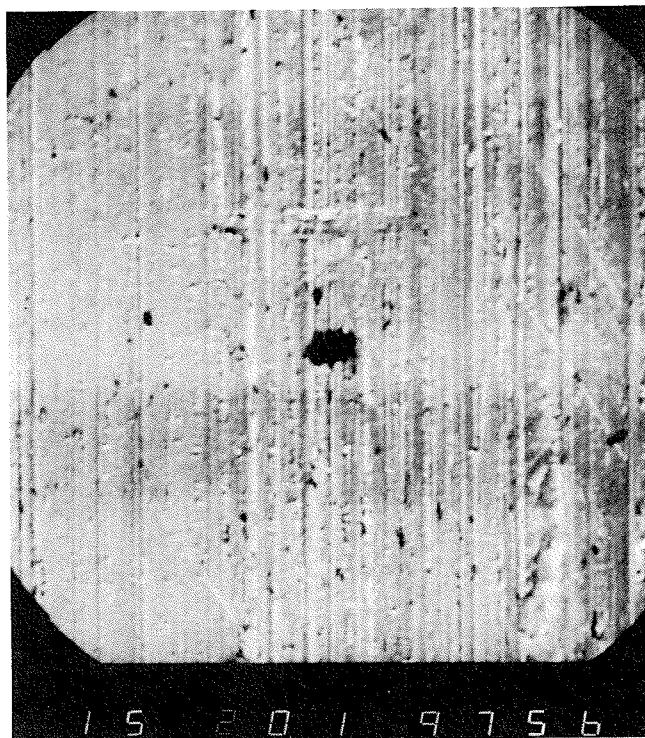
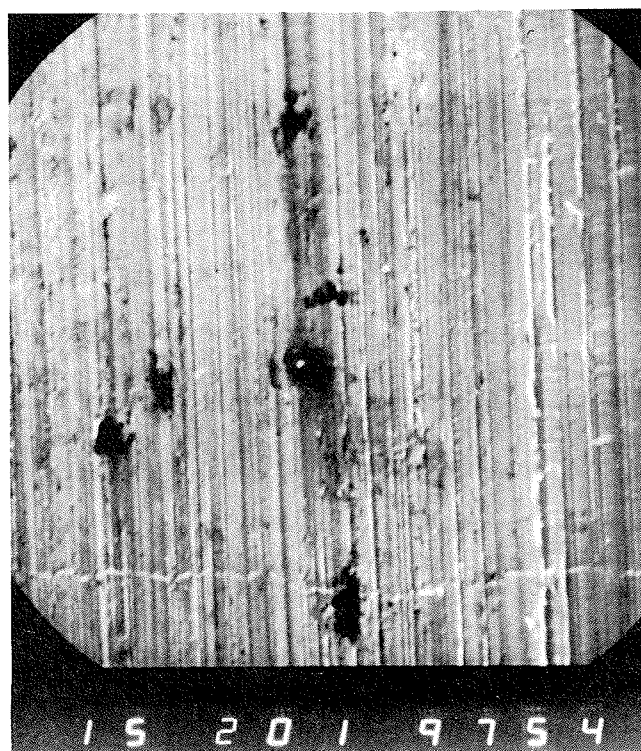
Fig. 7b: Pictures of the contaminated contact after outgassing
